Experimental Study ND 96-04

**Evaluation of CRAFCO  
Crack Sealant on  
Asphalt Pavements**

**Final Report**

Project H-5-085(004)041

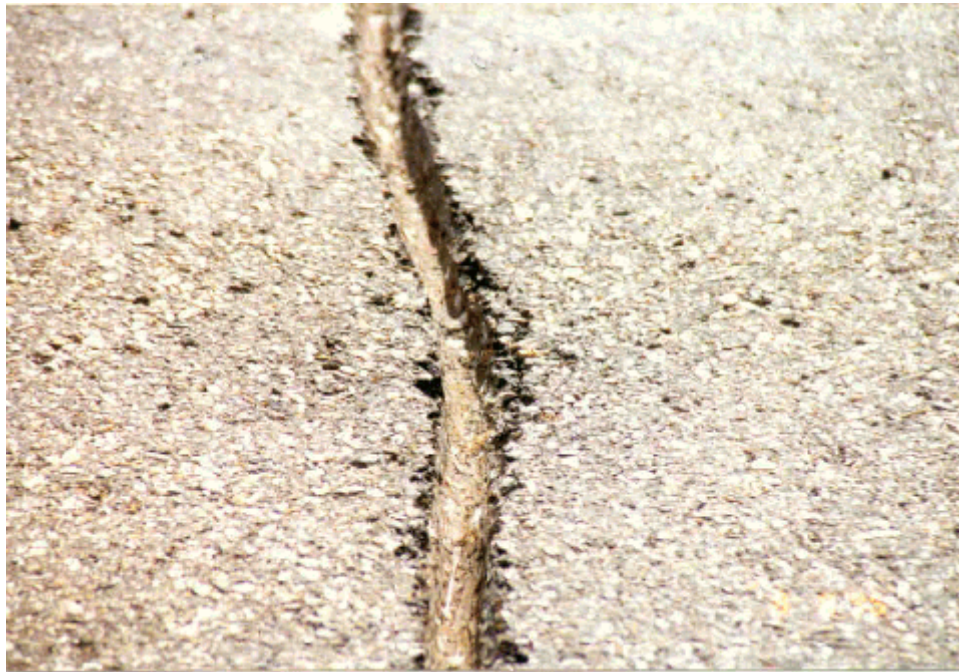
Problems can occur during the routing process. The cutting edges on the routers will wear down and become rounded. This is not acceptable as it will produce a reservoir that does not comply to construction requirements. A poor reservoir is shown in photo 1. Notice in photo 1 that the reservoir bottom is rounded. Also notice the surface edge is very irregular. Worn cutting wheels actually hammer their way through and can cause hairline cracks next to the

Photo 1  
Poor reservoir---worn cutting wheels on router.

vesseledge. These hairline cracks later show up as spalls.

It is vital to the success of the project to provide a routed vessel with vertical walls and a flat bottom. This means that the cutting wheels on a router must be kept in good condition. The requirements for routing are found in the project plan notes. Strict adherence to these requirements must be mandated. This would help to construct a properly routed crack that can provide optimum performance.

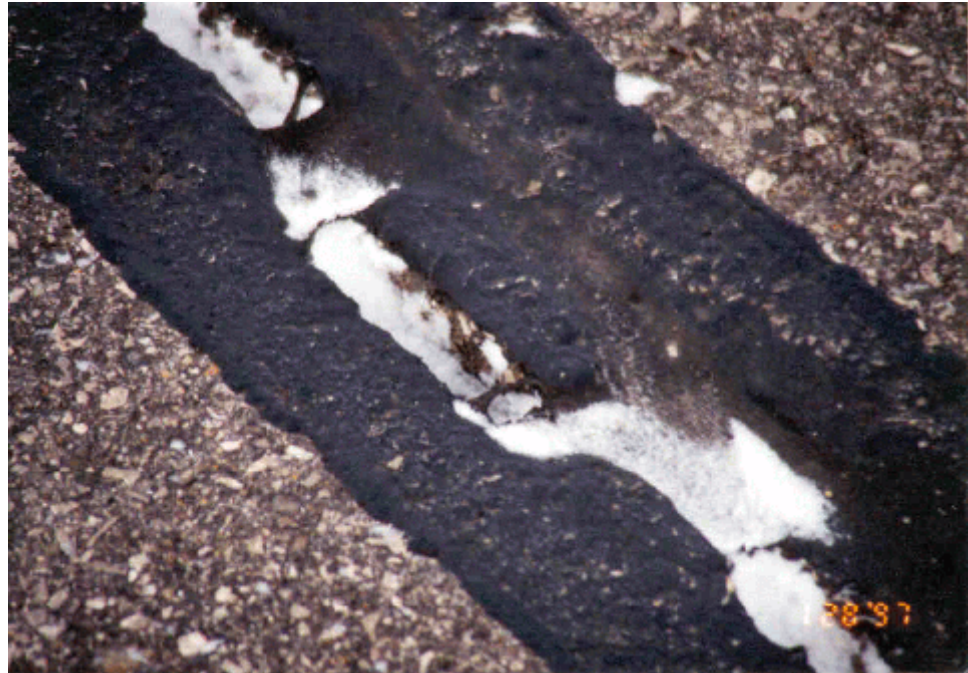
When referring to the open space in a crack that pulled away beyond the routed joint, I am referring to a crack that was missed during the routing process. The routed area is along side this crack and provides no benefit. These areas are counted as joint failures. Most failures occur due to poor crack routing.

Notice the routing to the right in photo 3. When this happens the sealant cannot protect the crack from moisture or incompressibles.

Photo 3  
Crafcro 231—failure—routing missed crack (winter 96/97)

Anytime cracks are routed and sealed, it can not be stressed enough the importance of obtaining a good vessel with vertical side walls and a flat bottom. Most importantly is the need to take the time to follow the crack as closely as possible with the router. Crafc0 230 and 231 sealants provided good performance in this study and are recommended for use. Although some of the problems were construction related and not necessarily product related, the Crafc0 sealants 522 and 521 in this study did not perform very well and are not recommended.

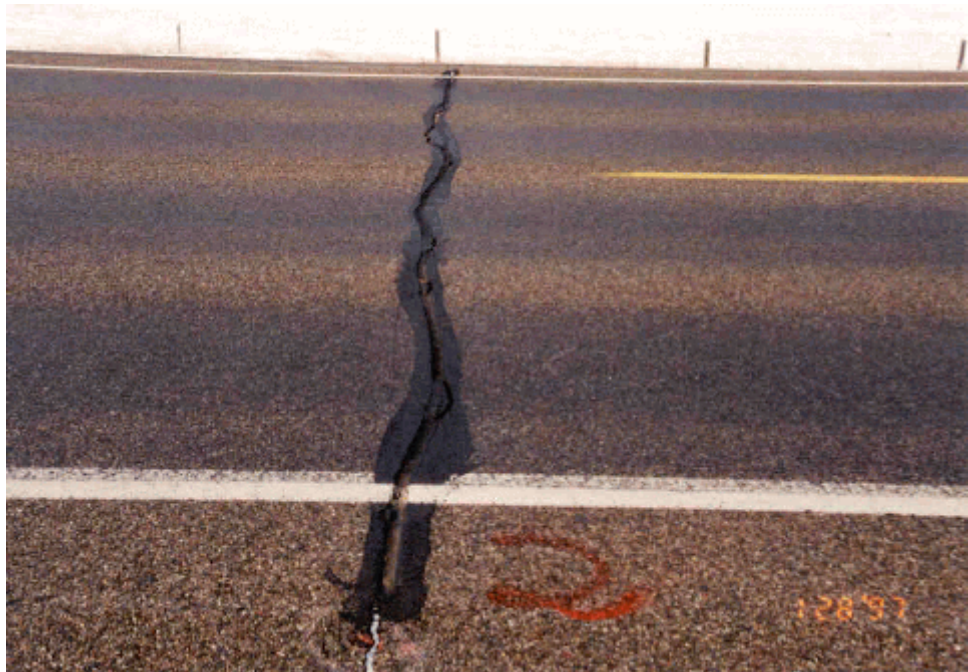
Photo 4 shows the same kind of failure. Notice the failure to follow the crack.

Photo 4  
Crafcro 230—failure—routing missed crack (winter 96/97)

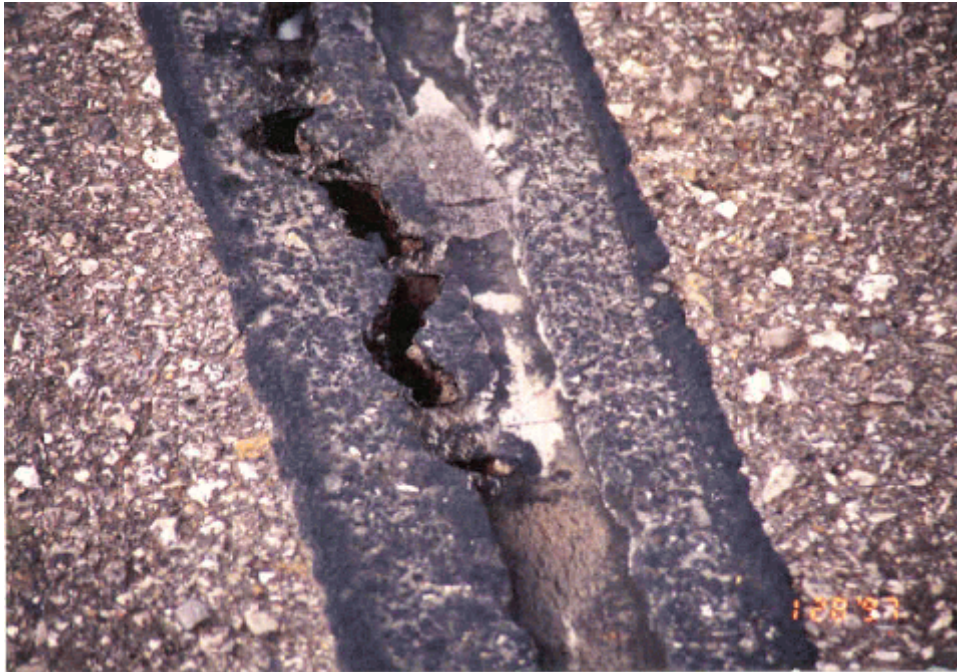
Photo 5 is a close-up of a routed crack in the Crafcro 522 section. In the top part of the picture, the crack is wide open. In the bottom part of the picture where the

Photo 5  
Crafco—failure—routing missed crack (winter 96/97)

routing is on the edge of the crack, the sealant has elongated enough to provide crack protection.

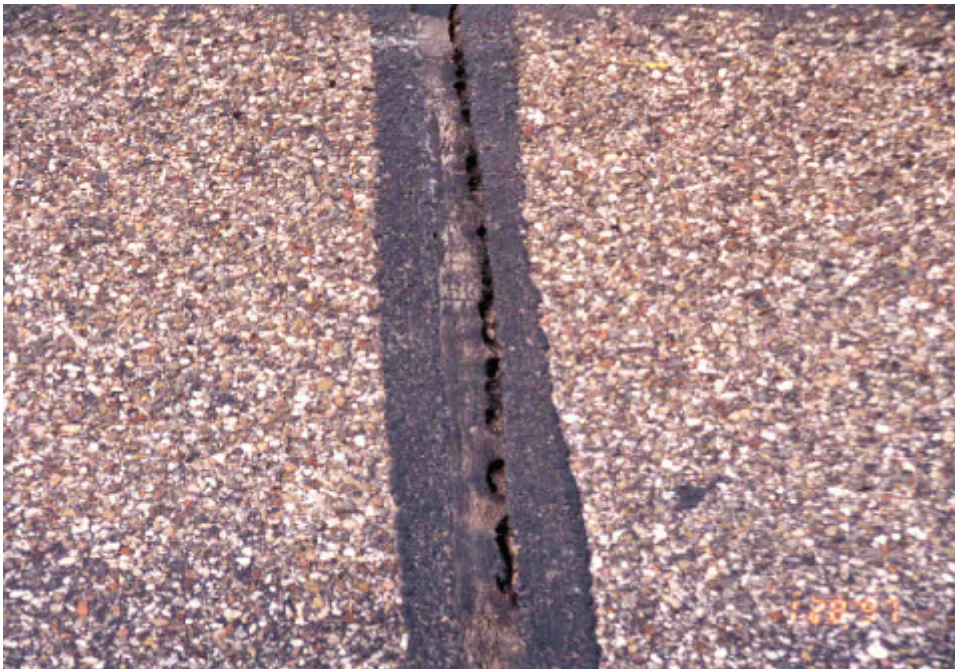
Crafco 221 sealant is the material that has the highest failure rating. The major cause for failure of this sealant is

adhesion. A typical adhesion failure

is seen in photo 6.

Photo 6  
Crafco 221—adhesion failure

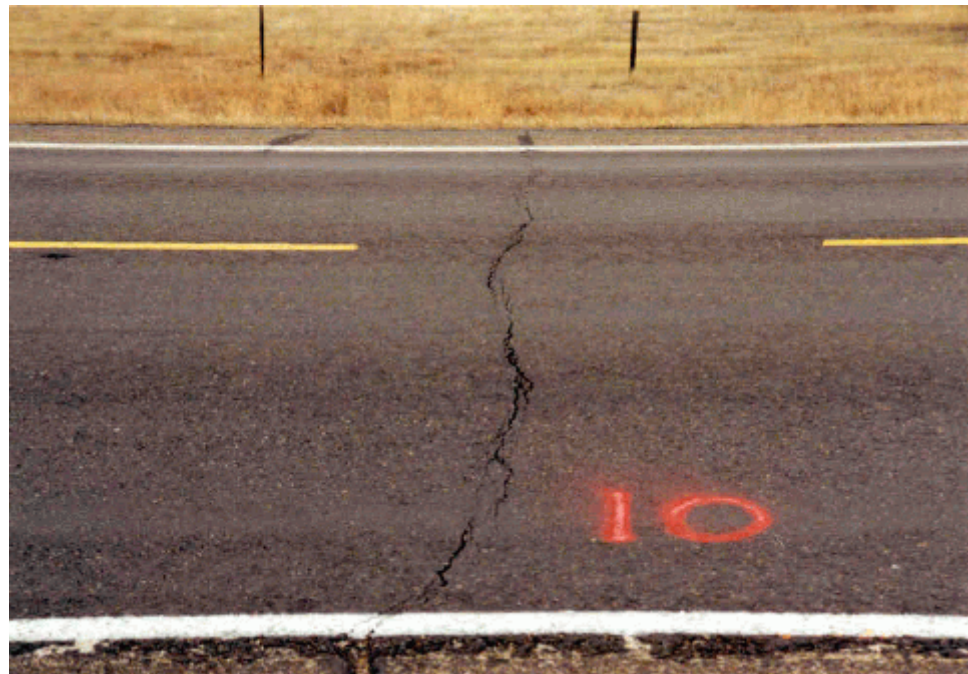
overlaid due to rutting. This section was extended to include about the same number of cracks as in the other sections. In some areas the entire roadway was overlaid. Photo 7 shows a

lane overlay at milepoint 52.308 in the Crafco 231 section.

The asphalt overlay has been in place for about a year and shows that the routed crack is reflected through the overlay.

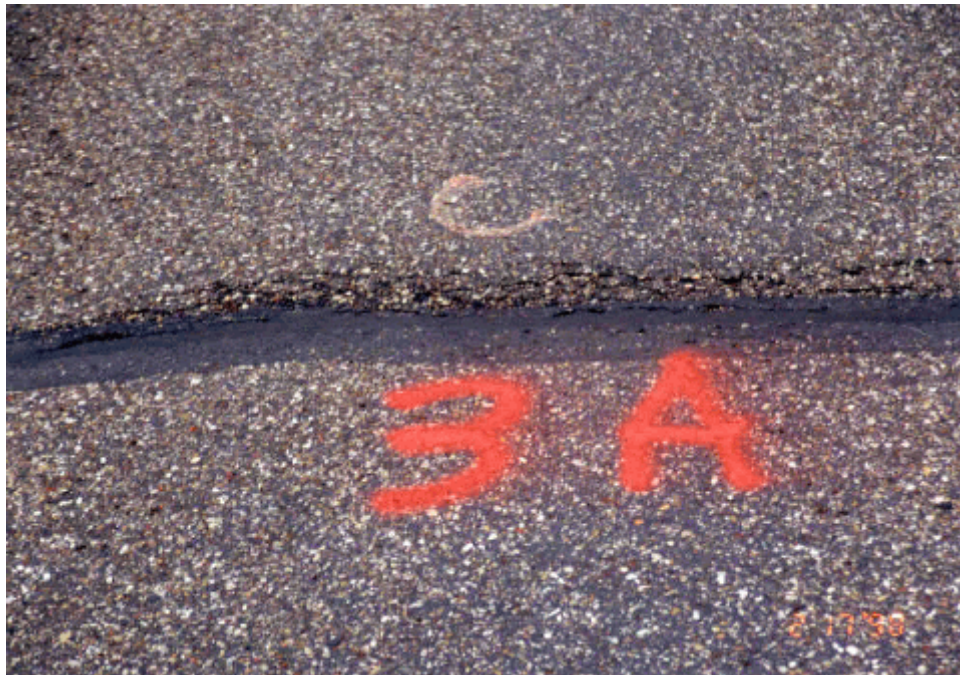
Depressed transverse cracks started showing up in 1997 and continued to increase in

Photo 8  
Depressed and multiple cracking--Crafcro 221 section

1998. Many of these are starting to become multiple cracked. See photo 8. The ride is being affected by these depressed cracks.

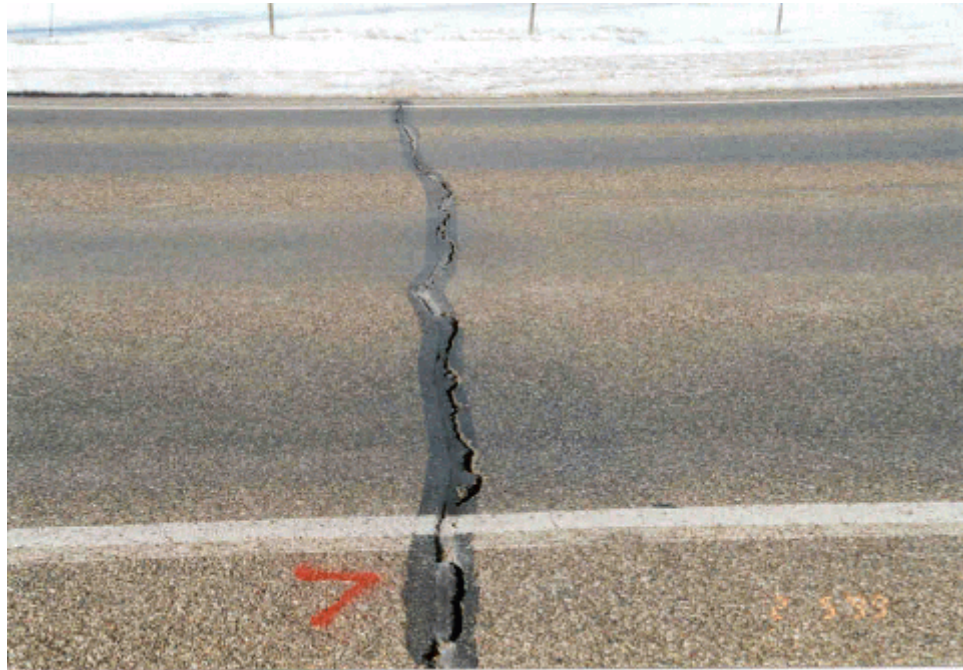
Two photos taken at the same crack location are shown on the next page. Photo 9 shows a typical bad crack during the early part of February 1999. This crack is located in the Crafcro 231 section. Photo 10 shows the same crack on May 5, 1999. This is not during the warmest part of the year, but already shows how the crack is closing up. This is why there can be such a difference between evaluators and also what time of year the evaluation occurs.

Photo 9  
Crafcro 231 section – February 1999 crack severity level

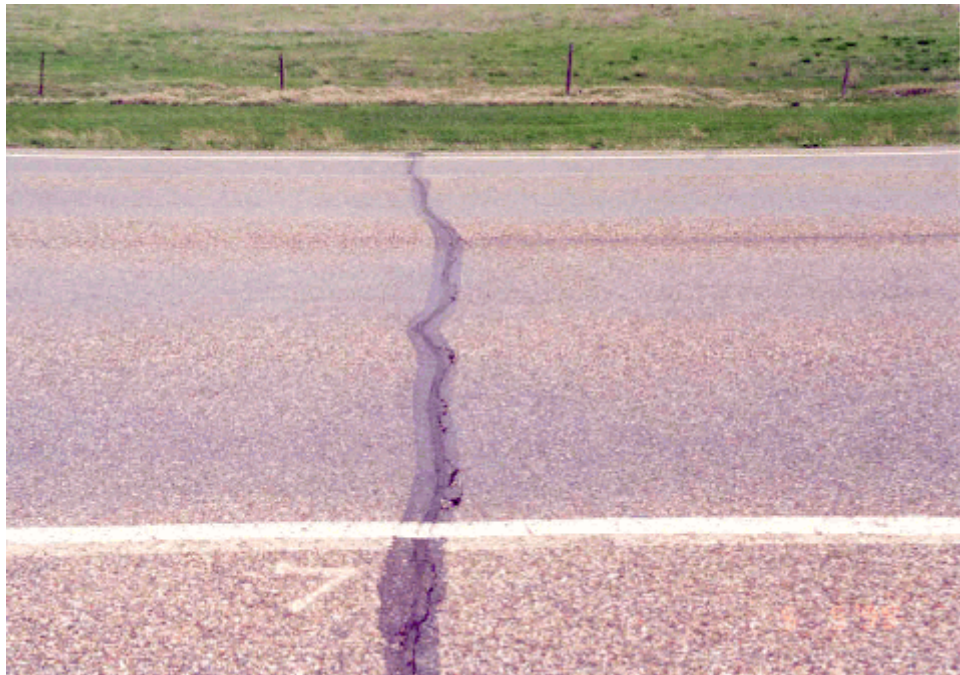
Photo 10  
Crafcro 231 section—Same crack as Photo 9 except taken on May 5, 1999  
You do not see as much failure—even though it is there

The section ratings are up over last year as expected by a summer time evaluation. Photos 9 and 10 from the 1999 evaluation show this very well. These photos show the visual difference of a cracks sealant failure between a winter and spring environment. Both materials were given the thumb test for flexibility and were judged equal. After four years of service both CrafcO Sealants 230 and 231 are performing satisfactorily.

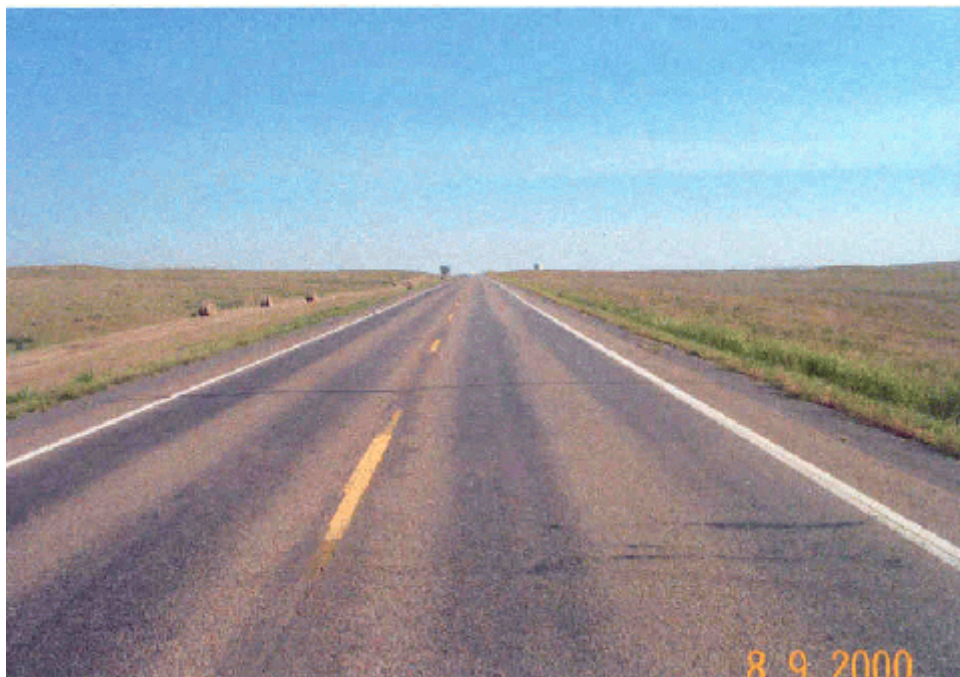
Photo 11  
Bleeding in wheel paths

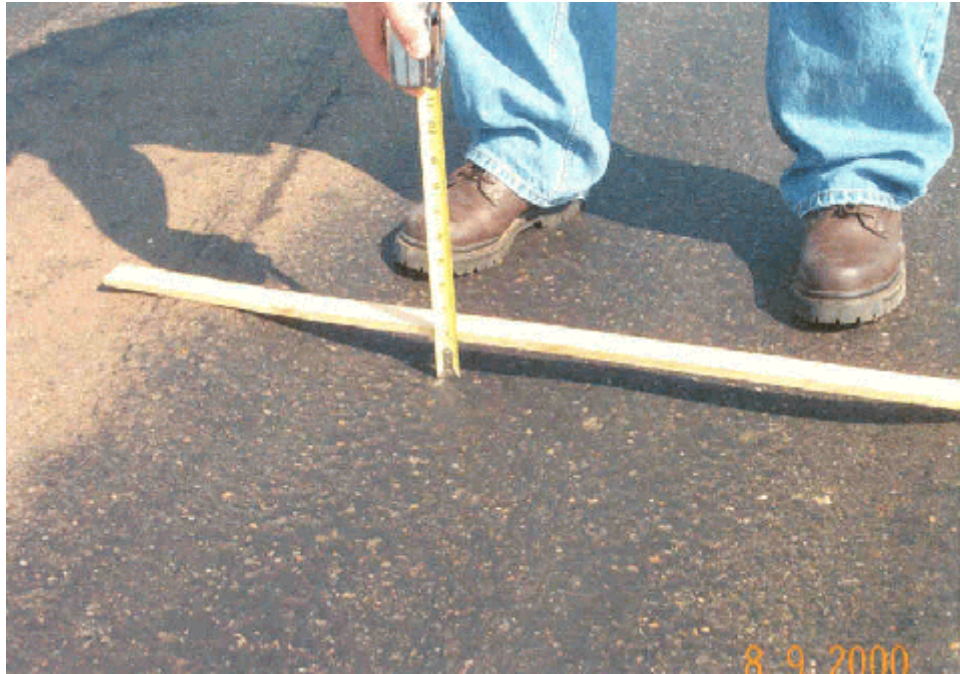
The Crafc0 230 section has been patched in some areas leaving only 23 cracks to evaluate. The cracks look like they are in rather good shape in this section but, some places are rutted over an inch. Photo 11 shows a sand seal where the asphalt is bleeding through. Photo 12 shows the depth of rutting at places in the Crafc0 230 section.

Photo 12  
Rutting in inside wheel path – SB

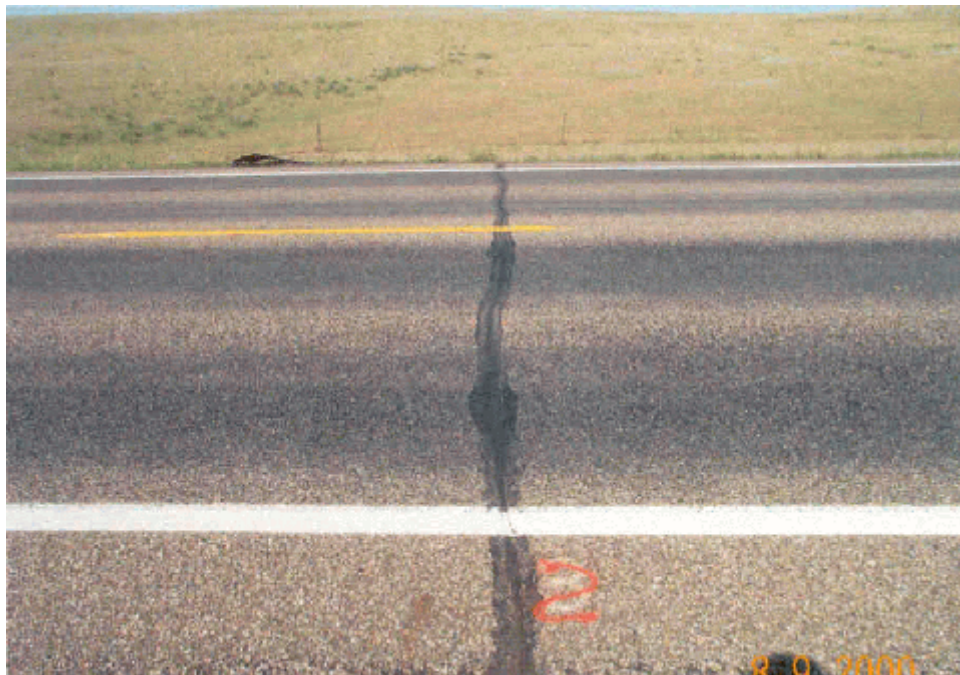
The Crafcro 231 section also has been overlaid in areas due to rutting. This section was extended in 1999 and has 52 cracks to evaluate. Photo 13 shows a typical crack in either the Crafcro 230 or 231 section.

Photo 13  
Typical crack found in Crafcro 230 or 231 section
